**PRE-REFURBISHMENT
ASBESTOS SURVEY REPORT**
for
Lakehouse
at
Scheme 38, 1-16 Farndale House

Job number	K0531	Reviewed by	K.Pearce
Date	14 th February 2011	Signature	 
Issue number	01	Authorised by	Craig Eighteen
Prepared by	J. Clark	Signature	 
Signature

Forest Environmental Ltd (FEL) was requested and authorised by Lakehouse in association with Avonline, to undertake a Pre-refurbishment Asbestos Survey ('Full access sampling and identification survey') at the Scheme 38, 1-16 Farndale House. The survey was carried out on the 09.02.2011 by Paul Riding.

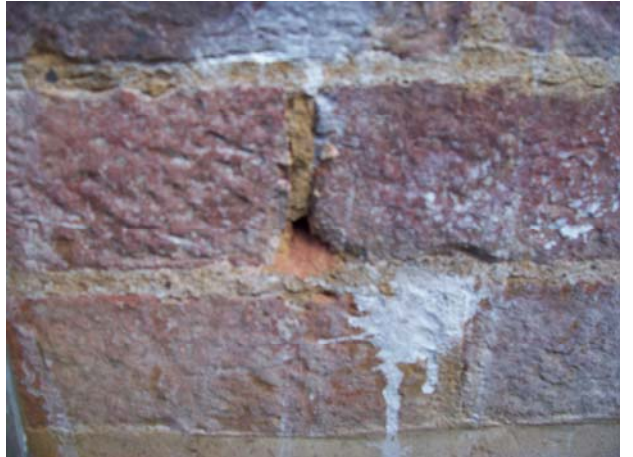
Inspection No:	1	Name of surveyors:	P.Riding		Date:	09.02.2011
Site/address:	Scheme 38, 1-16 Farndale House, Camden, London					
Asbestos detected:	No	Extent	Representative of cavity wall <1m ²	Sample No:	PR001-K0531	
Floor/level:	Ground	Element:	Core sample			
Area/room:	External	Location:	Wall cavity			
Inspection type:	Sampled					
MATERIAL ASSESSMENT						
Product type		1 = Composites, A/C etc.	2 = AIB, boards, ropes, gaskets, paper etc	3 = Lagging, sprayed coatings & loose asbestos		
Extent of damage	0 = Good condition	1 = Slight damage, marks & scratches	2 = Moderate damage	3 = Extensive damage, visible debris		
Surface treatment	0 = Composite materials, plastics, resins, tiles	1 = Enclosed sprays & laggings, sealed AIB, cement etc	2 = Unsealed AIB or sealed lagging & sprays	3 = Unsealed laggings & sprays		
Asbestos type		1 = Chrysotile	2 = Amphibole excluding Crocidolite	3 = Crocidolite		
Total Material Assessment Score:						0

Material assessment algorithm totals:		10-12 High risk	7-9 Medium risk	Outline risk category:	Not applicable	
		5-6 Low risk	<4 Very low risk			
Product type 2 or 3 materials will normally require notification to the appropriate body prior to removal under Fully Controlled Conditions.			Removal conditions relevant to this item:	N/A		
However these materials may be removed under Controlled Conditions if less than 1 m2 and/or less than 1 man hour work.						
Pre-Works Hazard Statement						
Is there a significant risk of exposure to respirable asbestos fibres for people entering this area in the period prior to pre-demolition asbestos removal works?						
Surveyor's Opinion:	No	Details:				
Is Immediate Action required?	No	Details:				
Concluding Information						
Comments: Non-asbestos containing core sample from wall and wall cavity.

Recommendations: No further action required.

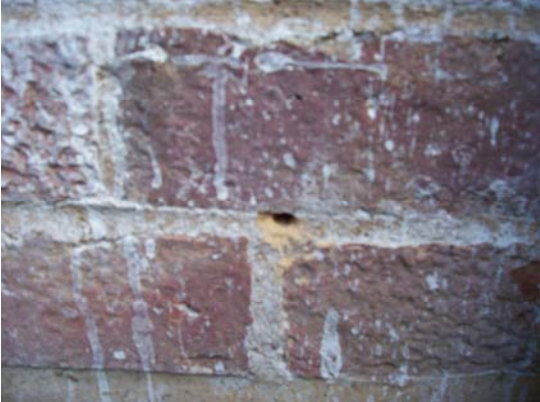
Inspection No:	2	Name of surveyors:	P.Riding		Date:	09.02.2011
Site/address:	Scheme 38, 1-16 Farndale House, Camden, London					
Asbestos detected:	No	Extent	Representative of cavity wall <1m ²	Sample No:	PR002-K0531	
Floor/level:	Ground	Element:	Core sample			
Area/room:	External	Location:	Wall cavity			
Inspection type:	Sampled					
MATERIAL ASSESSMENT						
Product type		1 = Composites, A/C etc.	2 = AIB, boards, ropes, gaskets, paper etc	3 = Lagging, sprayed coatings & loose asbestos		
Extent of damage	0 = Good condition	1 = Slight damage, marks & scratches	2 = Moderate damage	3 = Extensive damage, visible debris		
Surface treatment	0 = Composite materials, plastics, resins, tiles	1 = Enclosed sprays & laggings, sealed AIB, cement etc	2 = Unsealed AIB or sealed lagging & sprays	3 = Unsealed laggings & sprays		
Asbestos type		1 = Chrysotile	2 = Amphibole excluding Crocidolite	3 = Crocidolite		
Total Material Assessment Score:						0

Material assessment algorithm totals:		10-12 High risk	7-9 Medium risk	Outline risk category:	Not applicable	
		5-6 Low risk	<4 Very low risk			
<p>Product type 2 or 3 materials will normally require notification to the appropriate body prior to removal under Fully Controlled Conditions.</p> <p>However these materials may be removed under Controlled Conditions if less than 1 m2 and/or less than 1 man hour work.</p>			Removal conditions relevant to this item:	N/A		
Pre-Works Hazard Statement						
Is there a significant risk of exposure to respirable asbestos fibres for people entering this area in the period prior to pre-demolition asbestos removal works?						
Surveyor's Opinion:	No	Details:				
Is Immediate Action required?	No	Details:				
Concluding Information						
<p>Comments: Non-asbestos containing core sample from wall and wall cavity.</p>

<p>Recommendations: No further action required.</p>

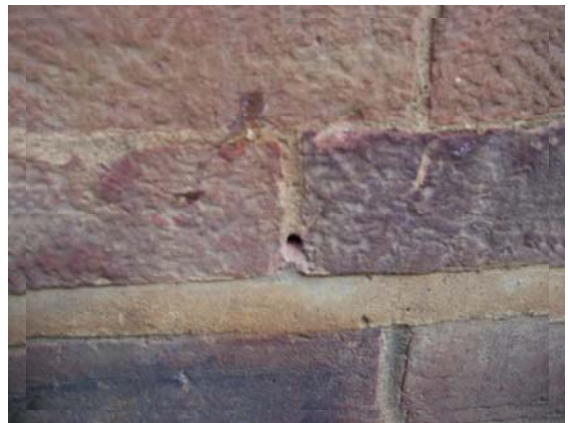
Inspection No:	3	Name of surveyors:	P.Riding		Date:	09.02.2011
Site/address:	Scheme 38, 1-16 Farndale House, Camden, London					
Asbestos detected:	No	Extent	Representative of cavity wall <1m ²	Sample No:	PR003-K0531	
Floor/level:	Ground	Element:	Core sample			
Area/room:	External	Location:	Wall cavity			
Inspection type:	Sampled					
MATERIAL ASSESSMENT						
Product type		1 = Composites, A/C etc.	2 = AIB, boards, ropes, gaskets, paper etc	3 = Lagging, sprayed coatings & loose asbestos		
Extent of damage	0 = Good condition	1 = Slight damage, marks & scratches	2 = Moderate damage	3 = Extensive damage, visible debris		
Surface treatment	0 = Composite materials, plastics, resins, tiles	1 = Enclosed sprays & laggings, sealed AIB, cement etc	2 = Unsealed AIB or sealed lagging & sprays	3 = Unsealed laggings & sprays		
Asbestos type		1 = Chrysotile	2 = Amphibole excluding Crocidolite	3 = Crocidolite		
Total Material Assessment Score:						0

Material assessment algorithm totals:		10-12 High risk	7-9 Medium risk	Outline risk category:	Not applicable	
		5-6 Low risk	<4 Very low risk			
Product type 2 or 3 materials will normally require notification to the appropriate body prior to removal under Fully Controlled Conditions. However these materials may be removed under Controlled Conditions if less than 1 m2 and/or less than 1 man hour work.			Removal conditions relevant to this item:	N/A		
Pre-Works Hazard Statement						
Is there a significant risk of exposure to respirable asbestos fibres for people entering this area in the period prior to pre-demolition asbestos removal works?						
Surveyor's Opinion:	No	Details:				
Is Immediate Action required?	No	Details:				
Concluding Information						
Comments: Non-asbestos containing core sample from wall and wall cavity.

Recommendations: No further action required.

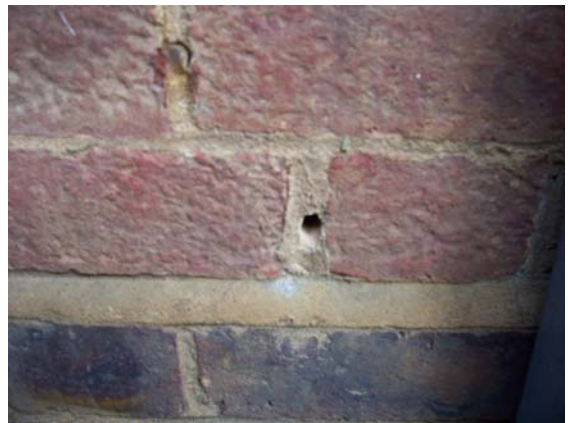
Inspection No:	4	Name of surveyors:	P.Riding		Date:	09.02.2011
Site/address:	Scheme 38, 1-16 Farndale House, Camden, London					
Asbestos detected:	No	Extent	Representative of cavity wall <1m ²	Sample No:	PR004-K0531	
Floor/level:	Ground	Element:	Core sample			
Area/room:	External	Location:	Wall cavity			
Inspection type:	Sampled					
MATERIAL ASSESSMENT						
Product type		1 = Composites, A/C etc.	2 = AIB, boards, ropes, gaskets, paper etc	3 = Lagging, sprayed coatings & loose asbestos		
Extent of damage	0 = Good condition	1 = Slight damage, marks & scratches	2 = Moderate damage	3 = Extensive damage, visible debris		
Surface treatment	0 = Composite materials, plastics, resins, tiles	1 = Enclosed sprays & laggings, sealed AIB, cement etc	2 = Unsealed AIB or sealed lagging & sprays	3 = Unsealed laggings & sprays		
Asbestos type		1 = Chrysotile	2 = Amphibole excluding Crocidolite	3 = Crocidolite		
Total Material Assessment Score:						0

Material assessment algorithm totals:		10-12 High risk	7-9 Medium risk	Outline risk category:	Not applicable	
		5-6 Low risk	<4 Very low risk			
<p>Product type 2 or 3 materials will normally require notification to the appropriate body prior to removal under Fully Controlled Conditions.</p> <p>However these materials may be removed under Controlled Conditions if less than 1 m2 and/or less than 1 man hour work.</p>			Removal conditions relevant to this item:	N/A		
Pre-Works Hazard Statement						
Is there a significant risk of exposure to respirable asbestos fibres for people entering this area in the period prior to pre-demolition asbestos removal works?						
Surveyor's Opinion:	No	Details:				
Is Immediate Action required?	No	Details:				
Concluding Information						
<p>Comments: Non-asbestos containing core sample from wall and wall cavity.</p>

<p>Recommendations: No further action required.</p>
