**PRE-REFURBISHMENT
ASBESTOS SURVEY REPORT**
for
Lakehouse
at
Scheme 38, 1-24 Lorton house

Job number	K0531	Reviewed by	K.Pearce
Date	14 th February 2011	Signature	 
Issue number	01	Authorised by	Craig Eighteen
Prepared by	J. Clark	Signature	 
Signature

No Asbestos Detected within the above site

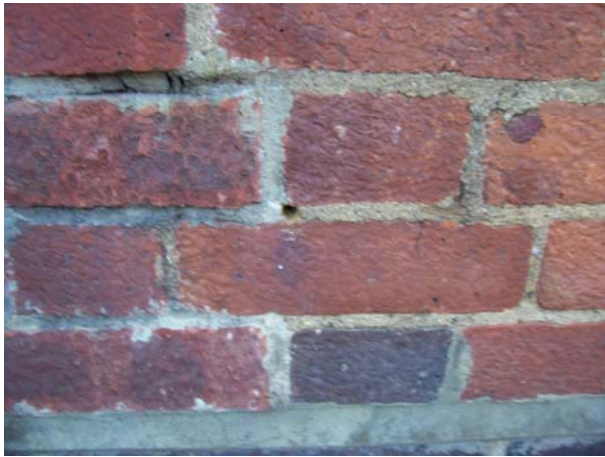
Inspection No:	1	Name of surveyors:	P.Riding		Date:	09.02.2011
Site/address:	Scheme 38, 1-24 Lorton House, Camden, London					
Asbestos detected:	No	Extent	Representative of cavity wall <1m ²	Sample No:	PR001-K0531	
Floor/level:	Ground		Element:	Core sample		
Area/room:	External		Location:	Wall cavity		
Inspection type:	Sampled					
MATERIAL ASSESSMENT						
Product type		1 = Composites, A/C etc.	2 = AIB, boards, ropes, gaskets, paper etc	3 = Lagging, sprayed coatings & loose asbestos		
Extent of damage	0 = Good condition	1 = Slight damage, marks & scratches	2 = Moderate damage	3 = Extensive damage, visible debris		
Surface treatment	0 = Composite materials, plastics, resins, tiles	1 = Enclosed sprays & laggings, sealed AIB, cement etc	2 = Unsealed AIB or sealed lagging & sprays	3 = Unsealed laggings & sprays		
Asbestos type		1 = Chrysotile	2 = Amphibole excluding Crocidolite	3 = Crocidolite		
Total Material Assessment Score:						0

Material assessment algorithm totals:		10-12 High risk	7-9 Medium risk	Outline risk category:	Not applicable	
		5-6 Low risk	<4 Very low risk			
Product type 2 or 3 materials will normally require notification to the appropriate body prior to removal under Fully Controlled Conditions.			Removal conditions relevant to this item:	N/A		
However these materials may be removed under Controlled Conditions if less than 1 m2 and/or less than 1 man hour work.						
Pre-Works Hazard Statement						
Is there a significant risk of exposure to respirable asbestos fibres for people entering this area in the period prior to pre-demolition asbestos removal works?						
Surveyor's Opinion:	No	Details:				
Is Immediate Action required?	No	Details:				
Concluding Information						
Comments: Non-asbestos containing core sample from wall and wall cavity.

Recommendations: No further action required.

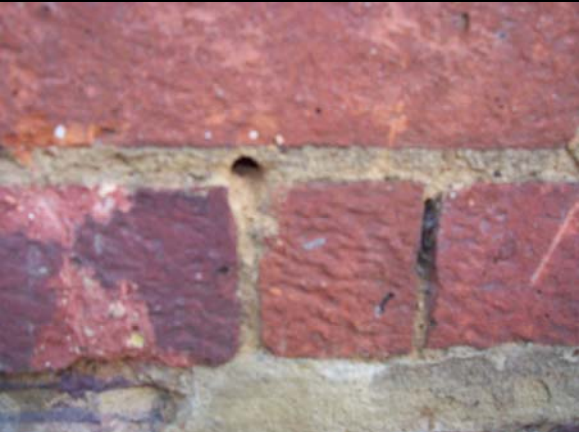
Inspection No:	2	Name of surveyors:	P.Riding		Date:	09.02.2011
Site/address:	Scheme 38, 1-24 Lorton House, Camden, London					
Asbestos detected:	No	Extent	Representative of cavity wall <math><1\text{m}^2</math>	Sample No:	PR002-K0531	
Floor/level:	Ground	Element:	Core sample			
Area/room:	External	Location:	Wall cavity			
Inspection type:	Sampled					
MATERIAL ASSESSMENT						
Product type		1 = Composites, A/C etc.	2 = AIB, boards, ropes, gaskets, paper etc	3 = Lagging, sprayed coatings & loose asbestos		
Extent of damage	0 = Good condition	1 = Slight damage, marks & scratches	2 = Moderate damage	3 = Extensive damage, visible debris		
Surface treatment	0 = Composite materials, plastics, resins, tiles	1 = Enclosed sprays & laggings, sealed AIB, cement etc	2 = Unsealed AIB or sealed lagging & sprays	3 = Unsealed laggings & sprays		
Asbestos type		1 = Chrysotile	2 = Amphibole excluding Crocidolite	3 = Crocidolite

Total Material Assessment Score:						0
Material assessment algorithm totals:		10-12 High risk	7-9 Medium risk	Outline risk category:	Not applicable	
		5-6 Low risk	<4 Very low risk			
Product type 2 or 3 materials will normally require notification to the appropriate body prior to removal under Fully Controlled Conditions. However these materials may be removed under Controlled Conditions if less than 1 m ² and/or less than 1 man hour work.			Removal conditions relevant to this item:	N/A		
Pre-Works Hazard Statement						
Is there a significant risk of exposure to respirable asbestos fibres for people entering this area in the period prior to pre-demolition asbestos removal works?						
Surveyor's Opinion:	No	Details:				
Is Immediate Action required?	No	Details:				
Concluding Information						
Comments: Non-asbestos containing core sample from wall and wall cavity.

Recommendations: No further action required.

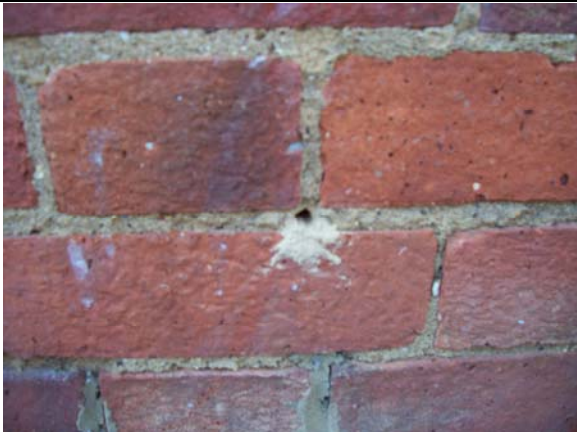
Inspection No:	3	Name of surveyors:	P.Riding		Date:	09.02.2011
Site/address:	Scheme 38, 1-24 Lorton House, Camden, London					
Asbestos detected:	No	Extent	Representative of cavity wall <1m ²	Sample No:	PR003-K0531	
Floor/level:	Ground		Element:	Core sample		
Area/room:	External		Location:	Wall cavity		
Inspection type:	Sampled					
MATERIAL ASSESSMENT						
Product type		1 = Composites, A/C etc.	2 = AIB, boards, ropes, gaskets, paper etc	3 = Lagging, sprayed coatings & loose asbestos		
Extent of damage	0 = Good condition	1 = Slight damage, marks & scratches	2 = Moderate damage	3 = Extensive damage, visible debris		
Surface treatment	0 = Composite materials, plastics, resins, tiles	1 = Enclosed sprays & laggings, sealed AIB, cement etc	2 = Unsealed AIB or sealed lagging & sprays	3 = Unsealed laggings & sprays		
Asbestos type		1 = Chrysotile	2 = Amphibole excluding Crocidolite	3 = Crocidolite		
Total Material Assessment Score:						0

Material assessment algorithm totals:		10-12 High risk	7-9 Medium risk	Outline risk category:	Not applicable	
		5-6 Low risk	<4 Very low risk			
Product type 2 or 3 materials will normally require notification to the appropriate body prior to removal under Fully Controlled Conditions.			Removal conditions relevant to this item:	N/A		
However these materials may be removed under Controlled Conditions if less than 1 m2 and/or less than 1 man hour work.						
Pre-Works Hazard Statement						
Is there a significant risk of exposure to respirable asbestos fibres for people entering this area in the period prior to pre-demolition asbestos removal works?						
Surveyor's Opinion:	No	Details:				
Is Immediate Action required?	No	Details:				
Concluding Information						
Comments: Non-asbestos containing core sample from wall and wall cavity.

Recommendations: No further action required.

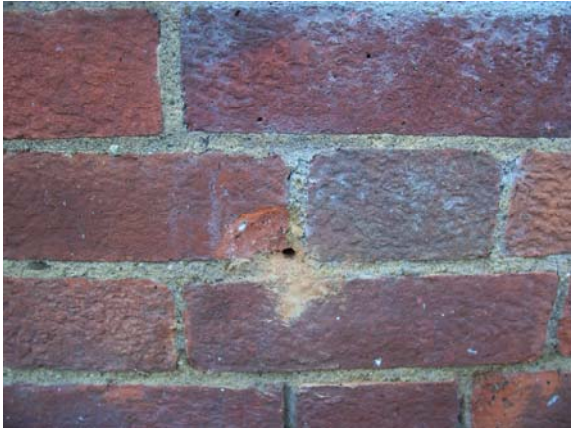
Inspection No:	4	Name of surveyors:	P.Riding		Date:	09.02.2011
Site/address:	Scheme 38, 1-24 Lorton House, Camden, London					
Asbestos detected:	No	Extent	Representative of cavity wall <1m ²	Sample No:	PR004-K0531	
Floor/level:	Ground	Element:	Core sample			
Area/room:	External	Location:	Wall cavity			
Inspection type:	Sampled					
MATERIAL ASSESSMENT						
Product type		1 = Composites, A/C etc.	2 = AIB, boards, ropes, gaskets, paper etc	3 = Lagging, sprayed coatings & loose asbestos		
Extent of damage	0 = Good condition	1 = Slight damage, marks & scratches	2 = Moderate damage	3 = Extensive damage, visible debris		
Surface treatment	0 = Composite materials, plastics, resins, tiles	1 = Enclosed sprays & laggings, sealed AIB, cement etc	2 = Unsealed AIB or sealed lagging & sprays	3 = Unsealed laggings & sprays		
Asbestos type		1 = Chrysotile	2 = Amphibole excluding Crocidolite	3 = Crocidolite		
Total Material Assessment Score:						0

Material assessment algorithm totals:		10-12 High risk	7-9 Medium risk	Outline risk category:	Not applicable	
		5-6 Low risk	<4 Very low risk			
<p>Product type 2 or 3 materials will normally require notification to the appropriate body prior to removal under Fully Controlled Conditions.</p> <p>However these materials may be removed under Controlled Conditions if less than 1 m2 and/or less than 1 man hour work.</p>			Removal conditions relevant to this item:	N/A		
Pre-Works Hazard Statement						
Is there a significant risk of exposure to respirable asbestos fibres for people entering this area in the period prior to pre-demolition asbestos removal works?						
Surveyor's Opinion:	No	Details:				
Is Immediate Action required?	No	Details:				
Concluding Information						
<p>Comments: Non-asbestos containing core sample from wall and wall cavity.</p>

<p>Recommendations: No further action required.</p>

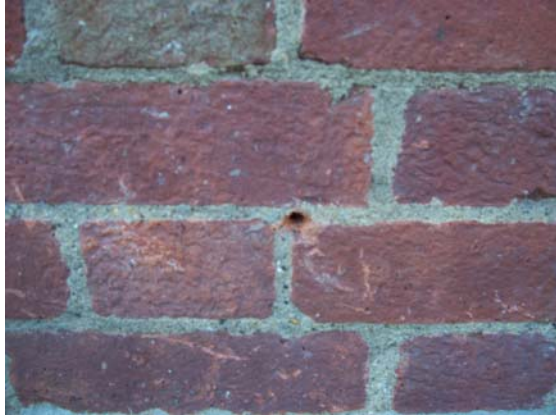
Inspection No:	5	Name of surveyors:	P.Riding		Date:	09.02.2011
Site/address:	Scheme 38, 1-24 Lorton House, Camden, London					
Asbestos detected:	No	Extent	Representative of cavity wall <1m ²	Sample No:	PR005-K0531	
Floor/level:	Ground	Element:	Core sample			
Area/room:	External	Location:	Wall cavity			
Inspection type:	Sampled					
MATERIAL ASSESSMENT						
Product type		1 = Composites, A/C etc.	2 = AIB, boards, ropes, gaskets, paper etc	3 = Lagging, sprayed coatings & loose asbestos		
Extent of damage	0 = Good condition	1 = Slight damage, marks & scratches	2 = Moderate damage	3 = Extensive damage, visible debris		
Surface treatment	0 = Composite materials, plastics, resins, tiles	1 = Enclosed sprays & laggings, sealed AIB, cement etc	2 = Unsealed AIB or sealed lagging & sprays	3 = Unsealed laggings & sprays		
Asbestos type		1 = Chrysotile	2 = Amphibole excluding Crocidolite	3 = Crocidolite		
Total Material Assessment Score:						0

Material assessment algorithm totals:		10-12 High risk	7-9 Medium risk	Outline risk category:	Not applicable	
		5-6 Low risk	<4 Very low risk			
Product type 2 or 3 materials will normally require notification to the appropriate body prior to removal under Fully Controlled Conditions. However these materials may be removed under Controlled Conditions if less than 1 m2 and/or less than 1 man hour work.			Removal conditions relevant to this item:	N/A		
Pre-Works Hazard Statement						
Is there a significant risk of exposure to respirable asbestos fibres for people entering this area in the period prior to pre-demolition asbestos removal works?						
Surveyor's Opinion:	No	Details:				
Is Immediate Action required?	No	Details:				
Concluding Information						
Comments: Non-asbestos containing core sample from wall and wall cavity.

Recommendations: No further action required.

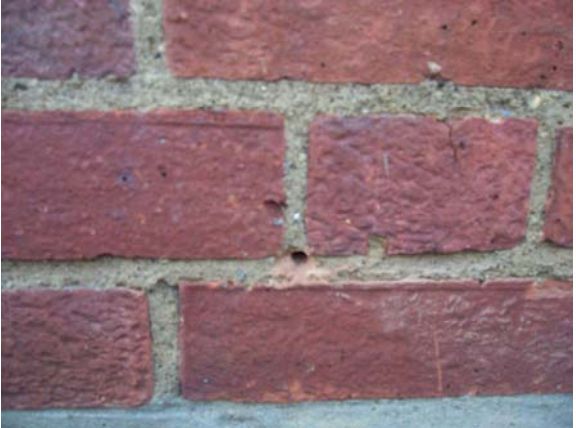
Inspection No:	6	Name of surveyors:	P.Riding		Date:	09.02.2011
Site/address:	Scheme 38, 1-24 Lorton House, Camden, London					
Asbestos detected:	No	Extent	Representative of cavity wall <1m ²	Sample No:	PR006-K0531	
Floor/level:	Ground	Element:	Core sample			
Area/room:	External	Location:	Wall cavity			
Inspection type:	Sampled					
MATERIAL ASSESSMENT						
Product type		1 = Composites, A/C etc.	2 = AIB, boards, ropes, gaskets, paper etc	3 = Lagging, sprayed coatings & loose asbestos		
Extent of damage	0 = Good condition	1 = Slight damage, marks & scratches	2 = Moderate damage	3 = Extensive damage, visible debris		
Surface treatment	0 = Composite materials, plastics, resins, tiles	1 = Enclosed sprays & laggings, sealed AIB, cement etc	2 = Unsealed AIB or sealed lagging & sprays	3 = Unsealed laggings & sprays		
Asbestos type		1 = Chrysotile	2 = Amphibole excluding Crocidolite	3 = Crocidolite		
Total Material Assessment Score:						0

Material assessment algorithm totals:		10-12 High risk	7-9 Medium risk	Outline risk category:	Not applicable	
		5-6 Low risk	<4 Very low risk			
<p>Product type 2 or 3 materials will normally require notification to the appropriate body prior to removal under Fully Controlled Conditions.</p> <p>However these materials may be removed under Controlled Conditions if less than 1 m2 and/or less than 1 man hour work.</p>			Removal conditions relevant to this item:	N/A		
Pre-Works Hazard Statement						
Is there a significant risk of exposure to respirable asbestos fibres for people entering this area in the period prior to pre-demolition asbestos removal works?						
Surveyor's Opinion:	No	Details:				
Is Immediate Action required?	No	Details:				
Concluding Information						
<p>Comments: Non-asbestos containing core sample from wall and wall cavity.</p>

<p>Recommendations: No further action required.</p>
