**PRE-REFURBISHMENT
ASBESTOS SURVEY REPORT**
for
Lakehouse
at
Scheme 38, 1-16 Marshwood House

Job number	K0531	Reviewed by	K.Pearce
Date	14 th February 2011	Signature	 
Issue number	01	Authorised by	Craig Eigheten
Prepared by	J. Clark	Signature

Forest Environmental Ltd (FEL) was requested and authorised by Lakehouse in association with Avonline, to undertake a Pre-refurbishment Asbestos Survey ('Full access sampling and identification survey') at the Scheme 38, 1-16 Marshwood House. The survey was carried out on the 09.02.2011 by Paul Riding.

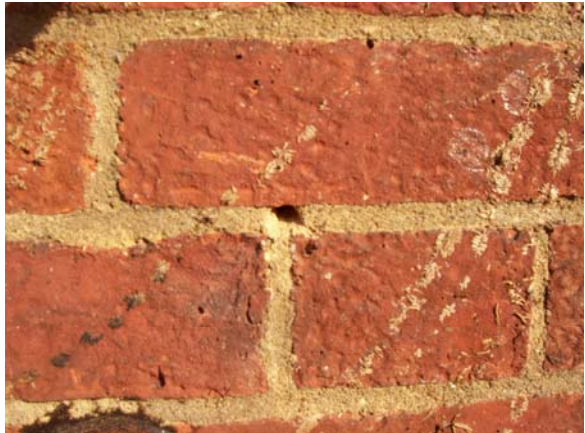
Inspection No:	1	Name of surveyors:	P.Riding		Date:	09.02.2011
Site/address:	Scheme 38, 1-16 Marshwood House, Camden, London					
Asbestos detected:	No	Extent	Representative of cavity wall <1m ²	Sample No:	PR001-K0531	
Floor/level:	Ground	Element:	Core sample			
Area/room:	External	Location:	Wall cavity			
Inspection type:	Sampled					
MATERIAL ASSESSMENT						
Product type		1 = Composites, A/C etc.	2 = AIB, boards, ropes, gaskets, paper etc	3 = Lagging, sprayed coatings & loose asbestos		
Extent of damage	0 = Good condition	1 = Slight damage, marks & scratches	2 = Moderate damage	3 = Extensive damage, visible debris		
Surface treatment	0 = Composite materials, plastics, resins, tiles	1 = Enclosed sprays & laggings, sealed AIB, cement etc	2 = Unsealed AIB or sealed lagging & sprays	3 = Unsealed laggings & sprays		
Asbestos type		1 = Chrysotile	2 = Amphibole excluding Crocidolite	3 = Crocidolite		
Total Material Assessment Score:						0

Material assessment algorithm totals:		10-12 High risk	7-9 Medium risk	Outline risk category:	Not applicable	
		5-6 Low risk	<4 Very low risk			
Product type 2 or 3 materials will normally require notification to the appropriate body prior to removal under Fully Controlled Conditions. However these materials may be removed under Controlled Conditions if less than 1 m2 and/or less than 1 man hour work.			Removal conditions relevant to this item:	N/A		
Pre-Works Hazard Statement						
Is there a significant risk of exposure to respirable asbestos fibres for people entering this area in the period prior to pre-demolition asbestos removal works?						
Surveyor's Opinion:	No	Details:				
Is Immediate Action required?	No	Details:				
Concluding Information						
Comments: Non-asbestos containing core sample from wall and wall cavity.

Recommendations: No further action required.

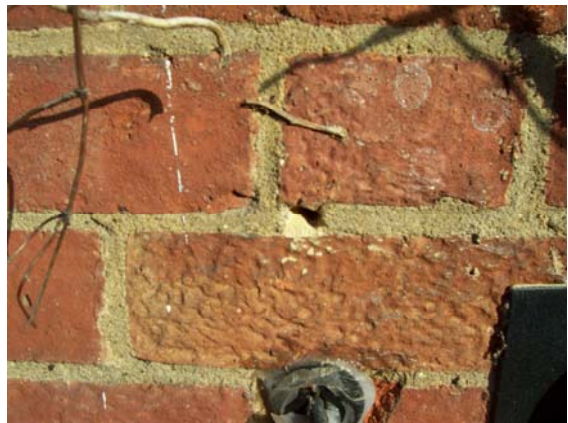
Inspection No:	2	Name of surveyors:	P.Riding		Date:	09.02.2011
Site/address:	Scheme 38, 1-16 Marshwood House, Camden, London					
Asbestos detected:	No	Extent	Representative of cavity wall <1m ²	Sample No:	PR002-K0531	
Floor/level:	Ground	Element:	Core sample			
Area/room:	External	Location:	Wall cavity			
Inspection type:	Sampled					
MATERIAL ASSESSMENT						
Product type		1 = Composites, A/C etc.	2 = AIB, boards, ropes, gaskets, paper etc	3 = Lagging, sprayed coatings & loose asbestos		
Extent of damage	0 = Good condition	1 = Slight damage, marks & scratches	2 = Moderate damage	3 = Extensive damage, visible debris		
Surface treatment	0 = Composite materials, plastics, resins, tiles	1 = Enclosed sprays & laggings, sealed AIB, cement etc	2 = Unsealed AIB or sealed lagging & sprays	3 = Unsealed laggings & sprays		
Asbestos type		1 = Chrysotile	2 = Amphibole excluding Crocidolite	3 = Crocidolite		
Total Material Assessment Score:						0

Material assessment algorithm totals:		10-12 High risk	7-9 Medium risk	Outline risk category:	Not applicable	
		5-6 Low risk	<4 Very low risk			
Product type 2 or 3 materials will normally require notification to the appropriate body prior to removal under Fully Controlled Conditions. However these materials may be removed under Controlled Conditions if less than 1 m2 and/or less than 1 man hour work.			Removal conditions relevant to this item:	N/A		
Pre-Works Hazard Statement						
Is there a significant risk of exposure to respirable asbestos fibres for people entering this area in the period prior to pre-demolition asbestos removal works?						
Surveyor's Opinion:	No	Details:				
Is Immediate Action required?	No	Details:				
Concluding Information						
Comments: Non-asbestos containing core sample from wall and wall cavity.

Recommendations: No further action required.

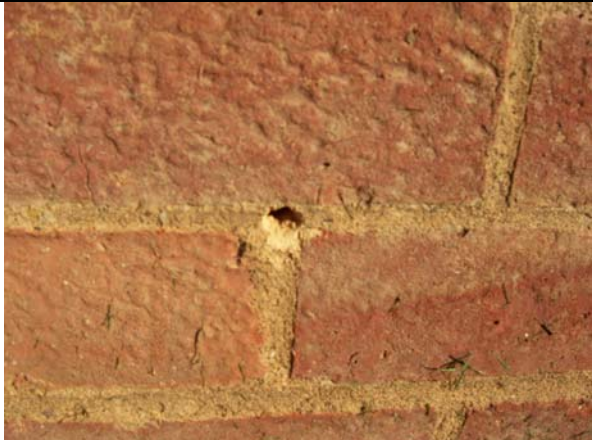
Inspection No:	3	Name of surveyors:	P.Riding		Date:	09.02.2011
Site/address:	Scheme 38, 1-16 Marshwood House, Camden, London					
Asbestos detected:	No	Extent	Representative of cavity wall <1m ²	Sample No:	PR003-K0531	
Floor/level:	Ground	Element:		Core sample		
Area/room:	External	Location:		Wall cavity		
Inspection type:	Sampled					
MATERIAL ASSESSMENT						
Product type		1 = Composites, A/C etc.	2 = AIB, boards, ropes, gaskets, paper etc	3 = Lagging, sprayed coatings & loose asbestos		
Extent of damage	0 = Good condition	1 = Slight damage, marks & scratches	2 = Moderate damage	3 = Extensive damage, visible debris		
Surface treatment	0 = Composite materials, plastics, resins, tiles	1 = Enclosed sprays & laggings, sealed AIB, cement etc	2 = Unsealed AIB or sealed lagging & sprays	3 = Unsealed laggings & sprays		
Asbestos type		1 = Chrysotile	2 = Amphibole excluding Crocidolite	3 = Crocidolite		
Total Material Assessment Score:						0

Material assessment algorithm totals:		10-12 High risk	7-9 Medium risk	Outline risk category:	Not applicable	
		5-6 Low risk	<4 Very low risk			
Product type 2 or 3 materials will normally require notification to the appropriate body prior to removal under Fully Controlled Conditions. However these materials may be removed under Controlled Conditions if less than 1 m2 and/or less than 1 man hour work.			Removal conditions relevant to this item:	N/A		
Pre-Works Hazard Statement						
Is there a significant risk of exposure to respirable asbestos fibres for people entering this area in the period prior to pre-demolition asbestos removal works?						
Surveyor's Opinion:	No	Details:				
Is Immediate Action required?	No	Details:				
Concluding Information						
Comments: Non-asbestos containing core sample from wall and wall cavity.

Recommendations: No further action required.

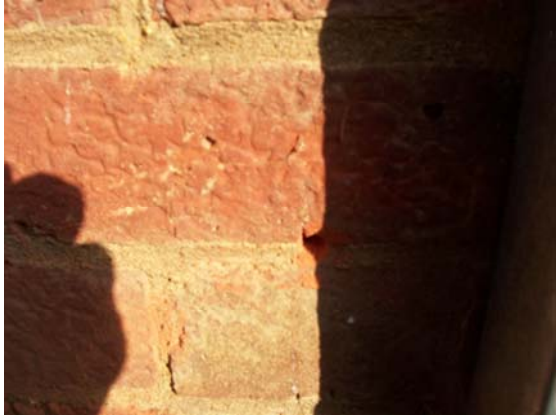
Inspection No:	4	Name of surveyors:	P.Riding		Date:	09.02.2011
Site/address:	Scheme 38, 1-16 Marshwood House, Camden, London					
Asbestos detected:	No	Extent	Representative of cavity wall <1m ²	Sample No:	PR004-K0531	
Floor/level:	Ground	Element:	Core sample			
Area/room:	External	Location:	Wall cavity			
Inspection type:	Sampled					
MATERIAL ASSESSMENT						
Product type		1 = Composites, A/C etc.	2 = AIB, boards, ropes, gaskets, paper etc	3 = Lagging, sprayed coatings & loose asbestos		
Extent of damage	0 = Good condition	1 = Slight damage, marks & scratches	2 = Moderate damage	3 = Extensive damage, visible debris		
Surface treatment	0 = Composite materials, plastics, resins, tiles	1 = Enclosed sprays & laggings, sealed AIB, cement etc	2 = Unsealed AIB or sealed lagging & sprays	3 = Unsealed laggings & sprays		
Asbestos type		1 = Chrysotile	2 = Amphibole excluding Crocidolite	3 = Crocidolite		
Total Material Assessment Score:						0

Material assessment algorithm totals:		10-12 High risk	7-9 Medium risk	Outline risk category:	Not applicable	
		5-6 Low risk	<4 Very low risk			
Product type 2 or 3 materials will normally require notification to the appropriate body prior to removal under Fully Controlled Conditions. However these materials may be removed under Controlled Conditions if less than 1 m2 and/or less than 1 man hour work.			Removal conditions relevant to this item:	N/A		
Pre-Works Hazard Statement						
Is there a significant risk of exposure to respirable asbestos fibres for people entering this area in the period prior to pre-demolition asbestos removal works?						
Surveyor's Opinion:	No	Details:				
Is Immediate Action required?	No	Details:				
Concluding Information						
Comments: Non-asbestos containing core sample from wall and wall cavity.

Recommendations: No further action required.
