**PRE-REFURBISHMENT  
ASBESTOS SURVEY REPORT**  
for  
**Lakehouse**  
at  
**Scheme 38, 1-16 Ribblesdale House**

Job number	K0531	Reviewed by	K.Pearce
Date	14 <sup>th</sup> February 2011	Signature

Forest Environmental Ltd (FEL) was requested and authorised by Lakehouse in association with Avonline, to undertake a Pre-refurbishment Asbestos Survey ('Full access sampling and identification survey') at the Scheme 38, 1-16 Ribblesdale House. The survey was carried out on the 09.02.2011 by Paul Riding.

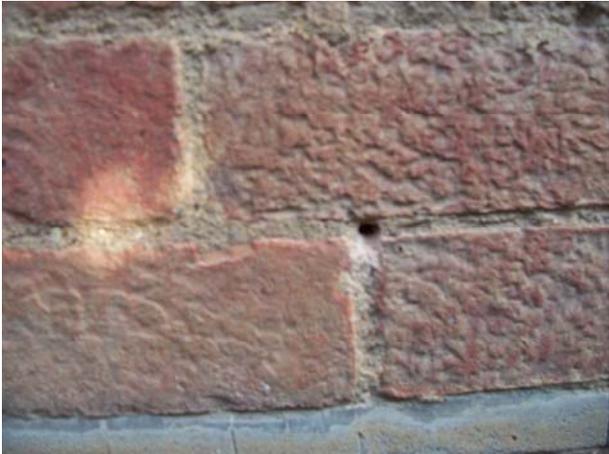
<b>Inspection No:</b>	1	<b>Name of surveyors:</b>	P.Riding		<b>Date:</b>	09.02.2011
<b>Site/address:</b>	Scheme 38, 1-16 Ribblesdale House, Camden, London					
<b>Asbestos detected:</b>	No	<b>Extent</b>	Representative of cavity wall <1m <sup>2</sup>	<b>Sample No:</b>	PR001-K0531	
<b>Floor/level:</b>	Ground	<b>Element:</b>	Core sample			
<b>Area/room:</b>	External	<b>Location:</b>	Wall cavity			
<b>Inspection type:</b>	Sampled					
<b>MATERIAL ASSESSMENT</b>						
<b>Product type</b>		1 = Composites, A/C etc.	2 = AIB, boards, ropes, gaskets, paper etc	3 = Lagging, sprayed coatings & loose asbestos		
<b>Extent of damage</b>	0 = Good condition	1 = Slight damage, marks & scratches	2 = Moderate damage	3 = Extensive damage, visible debris		
<b>Surface treatment</b>	0 = Composite materials, plastics, resins, tiles	1 = Enclosed sprays & laggings, sealed AIB, cement etc	2 = Unsealed AIB or sealed lagging & sprays	3 = Unsealed laggings & sprays

Concluding Information						
<b>Comments:</b> Non-asbestos containing core sample from wall and wall cavity.

<b>Recommendations:</b> No further action required.

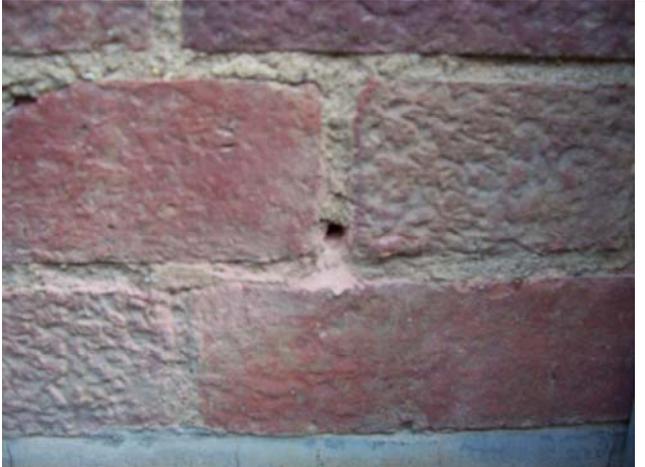
<b>Inspection No:</b>	2	<b>Name of surveyors:</b>	P.Riding		<b>Date:</b>	09.02.2011
<b>Site/address:</b>	Scheme 38, 1-16 Ribblesdale House, Camden, London					
<b>Asbestos detected:</b>	No	<b>Extent</b>	Representative of cavity wall <1m <sup>2</sup>	<b>Sample No:</b>	PR002-K0531	
<b>Floor/level:</b>	Ground		<b>Element:</b>	Core sample		
<b>Area/room:</b>	External		<b>Location:</b>	Wall cavity		
<b>Inspection type:</b>	Sampled					
<b>MATERIAL ASSESSMENT</b>						
<b>Product type</b>		1 = Composites, A/C etc.	2 = AIB, boards, ropes, gaskets, paper etc	3 = Laggings, sprayed coatings & loose asbestos		
<b>Extent of damage</b>	0 = Good condition	1 = Slight damage, marks & scratches	2 = Moderate damage	3 = Extensive damage, visible debris		
<b>Surface treatment</b>	0 = Composite materials, plastics, resins, tiles	1 = Enclosed sprays & laggings, sealed AIB, cement etc	2 = Unsealed AIB or sealed lagging & sprays	3 = Unsealed laggings & sprays

Concluding Information						
<p><b>Comments:</b> Non-asbestos containing core sample from wall and wall cavity.</p>

<p><b>Recommendations:</b> No further action required.</p>

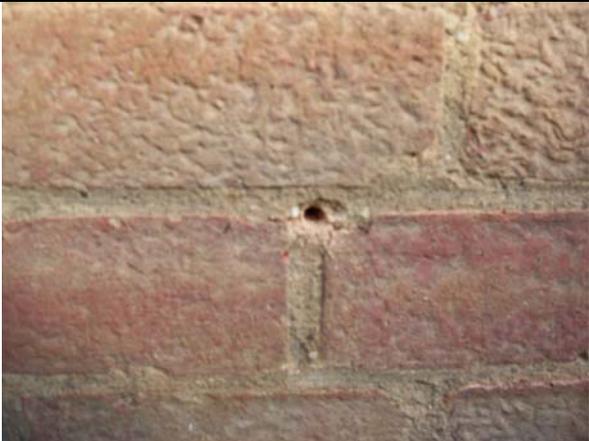
<b>Inspection No:</b>	3	<b>Name of surveyors:</b>	P.Riding		<b>Date:</b>	09.02.2011
<b>Site/address:</b>	Scheme 38, 1-16 Ribblesdale House, Camden, London					
<b>Asbestos detected:</b>	No	<b>Extent</b>	Representative of cavity wall <1m <sup>2</sup>	<b>Sample No:</b>	PR003-K0531	
<b>Floor/level:</b>	Ground	<b>Element:</b>		Core sample		
<b>Area/room:</b>	External	<b>Location:</b>		Wall cavity		
<b>Inspection type:</b>	Sampled					
<b>MATERIAL ASSESSMENT</b>						
<b>Product type</b>		1 = Composites, A/C etc.	2 = AIB, boards, ropes, gaskets, paper etc	3 = Lagging, sprayed coatings & loose asbestos		
<b>Extent of damage</b>	0 = Good condition	1 = Slight damage, marks & scratches	2 = Moderate damage	3 = Extensive damage, visible debris		
<b>Surface treatment</b>	0 = Composite materials, plastics, resins, tiles	1 = Enclosed sprays & laggings, sealed AIB, cement etc	2 = Unsealed AIB or sealed lagging & sprays	3 = Unsealed laggings & sprays

Concluding Information						
<b>Comments:</b> Non-asbestos containing core sample from wall and wall cavity.

<b>Recommendations:</b> No further action required.

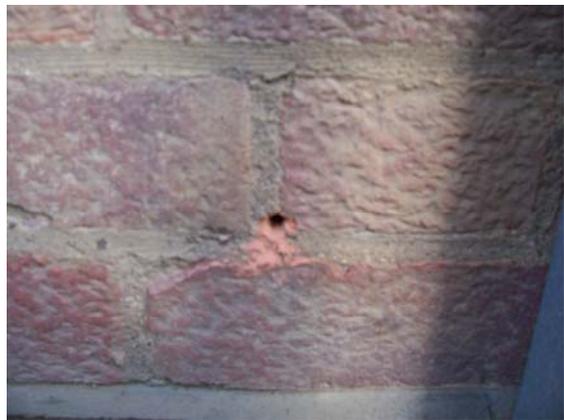
Inspection No:	4	Name of surveyors:	P.Riding		Date:	09.02.2011
Site/address:	Scheme 38, 1-16 Ribblesdale House, Camden, London					
Asbestos detected:	No	Extent	Representative of cavity wall <1m <sup>2</sup>	Sample No:	PR004-K0531	
Floor/level:	Ground	Element:	Core sample			
Area/room:	External	Location:	Wall cavity			
Inspection type:	Sampled					
<b>MATERIAL ASSESSMENT</b>						
Product type		1 = Composites, A/C etc.	2 = AIB, boards, ropes, gaskets, paper etc	3 = Lagging, sprayed coatings & loose asbestos		
Extent of damage	0 = Good condition	1 = Slight damage, marks & scratches	2 = Moderate damage	3 = Extensive damage, visible debris		
Surface treatment	0 = Composite materials, plastics, resins, tiles	1 = Enclosed sprays & laggings, sealed AIB, cement etc	2 = Unsealed AIB or sealed lagging & sprays	3 = Unsealed laggings & sprays		
Asbestos type		1 = Chrysotile	2 = Amphibole excluding Crocidolite	3 = Crocidolite

<b>Total Material Assessment Score:</b>						<b>0</b>
<b>Material assessment algorithm totals:</b>		10-12 High risk	7-9 Medium risk	Outline risk category:	Not applicable	
		5-6 Low risk	<4 Very low risk			
<p><b>Product type 2 or 3</b> materials will normally require notification to the appropriate body prior to removal under Fully Controlled Conditions.</p> <p>However these materials may be removed under Controlled Conditions if less than 1 m2 and/or less than 1 man hour work.</p>			Removal conditions relevant to this item:	<b>N/A</b>		
<b>Pre-Works Hazard Statement</b>						
Is there a significant risk of exposure to respirable asbestos fibres for people entering this area in the period prior to pre-demolition asbestos removal works?						
Surveyor's Opinion:	No	Details:				
Is Immediate Action required?	No	Details:				
Concluding Information						
<p><b>Comments:</b> Non-asbestos containing core sample from wall and wall cavity.</p>

<p><b>Recommendations:</b> No further action required.</p>
