**PRE-REFURBISHMENT
ASBESTOS SURVEY REPORT**
for
Lakehouse
at
Scheme 38, 1-12 Bishopsdale House

Job number	K0531	Reviewed by	K.Pearce
Date	14 th February 2011	Signature

Forest Environmental Ltd (FEL) was requested and authorised by Lakehouse in association with Avonline, to undertake a Pre-refurbishment Asbestos Survey ('Full access sampling and identification survey') at the Scheme 38, 1-12 Bishopsdale. The survey was carried out on the 09.02.2011 by Paul Riding.

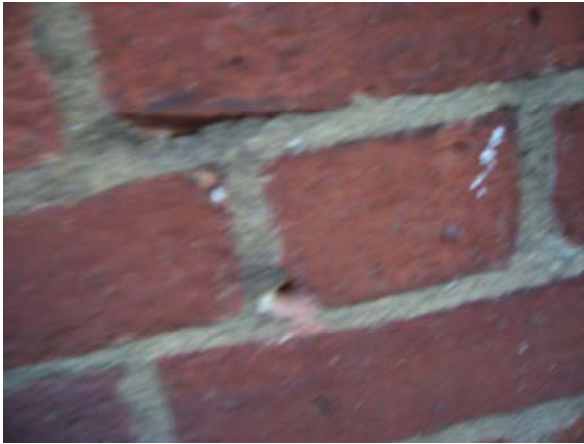
Inspection No:	1	Name of surveyors:	P.Riding		Date:	09.02.2011
Site/address:	Scheme 38, 1-12 Bishopsdale House, Camden, London					
Asbestos detected:	No	Extent	Representative of cavity wall <1m ²	Sample No:	PR001-K0531	
Floor/level:	Ground	Element:	Core sample			
Area/room:	External	Location:	Wall cavity			
Inspection type:	Sampled					
MATERIAL ASSESSMENT						
Product type		1 = Composites, A/C etc.	2 = AIB, boards, ropes, gaskets, paper etc	3 = Lagging, sprayed coatings & loose asbestos		
Extent of damage	0 = Good condition	1 = Slight damage, marks & scratches	2 = Moderate damage	3 = Extensive damage, visible debris		
Surface treatment	0 = Composite materials, plastics, resins, tiles	1 = Enclosed sprays & laggings, sealed AIB, cement etc	2 = Unsealed AIB or sealed lagging & sprays	3 = Unsealed laggings & sprays		
Asbestos type		1 = Chrysotile	2 = Amphibole excluding Crocidolite	3 = Crocidolite

Total Material Assessment Score:					0	
Material assessment algorithm totals:		10-12 High risk	7-9 Medium risk	Outline risk category:	Not applicable	
		5-6 Low risk	<4 Very low risk			
<p>Product type 2 or 3 materials will normally require notification to the appropriate body prior to removal under Fully Controlled Conditions.</p> <p>However these materials may be removed under Controlled Conditions if less than 1 m2 and/or less than 1 man hour work.</p>			Removal conditions relevant to this item:	N/A		
Pre-Works Hazard Statement						
Is there a significant risk of exposure to respirable asbestos fibres for people entering this area in the period prior to pre-demolition asbestos removal works?						
Surveyor's Opinion:	No	Details:				
Is Immediate Action required?	No	Details:				
Concluding Information						
<p>Comments: Non-asbestos containing core sample from wall and wall cavity.</p>

<p>Recommendations: No further action required.</p>

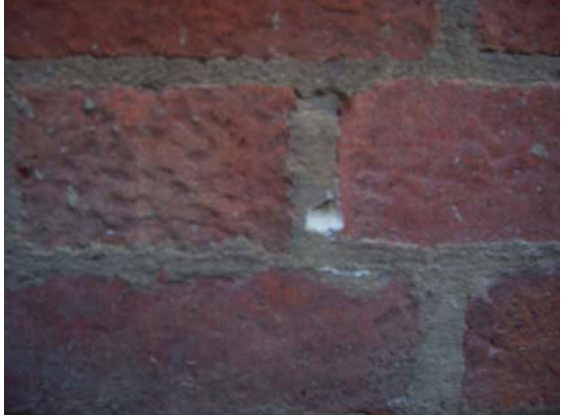
Inspection No:	2	Name of surveyors:	P.Riding		Date:	09.02.2011
Site/address:	Scheme 38, 1-12 Bishopsdale House, Camden, London					
Asbestos detected:	No	Extent	Representative of cavity wall <1m ²	Sample No:	PR002-K0531	
Floor/level:	Ground	Element:	Core sample			
Area/room:	External	Location:	Wall cavity			
Inspection type:	Sampled					
MATERIAL ASSESSMENT						
Product type		1 = Composites, A/C etc.	2 = AIB, boards, ropes, gaskets, paper etc	3 = Lagging, sprayed coatings & loose asbestos		
Extent of damage	0 = Good condition	1 = Slight damage, marks & scratches	2 = Moderate damage	3 = Extensive damage, visible debris		
Surface treatment	0 = Composite materials, plastics, resins, tiles	1 = Enclosed sprays & laggings, sealed AIB, cement etc	2 = Unsealed AIB or sealed lagging & sprays	3 = Unsealed laggings & sprays		
Asbestos type		1 = Chrysotile	2 = Amphibole excluding Crocidolite	3 = Crocidolite

Total Material Assessment Score:						0
Material assessment algorithm totals:		10-12 High risk	7-9 Medium risk	Outline risk category:	Not applicable	
		5-6 Low risk	<4 Very low risk			
<p>Product type 2 or 3 materials will normally require notification to the appropriate body prior to removal under Fully Controlled Conditions.</p> <p>However these materials may be removed under Controlled Conditions if less than 1 m2 and/or less than 1 man hour work.</p>			Removal conditions relevant to this item:	N/A		
Pre-Works Hazard Statement						
Is there a significant risk of exposure to respirable asbestos fibres for people entering this area in the period prior to pre-demolition asbestos removal works?						
Surveyor's Opinion:	No	Details:				
Is Immediate Action required?	No	Details:				
Concluding Information						
<p>Comments: Non-asbestos containing core sample from wall and wall cavity.</p>

<p>Recommendations: No further action required.</p>

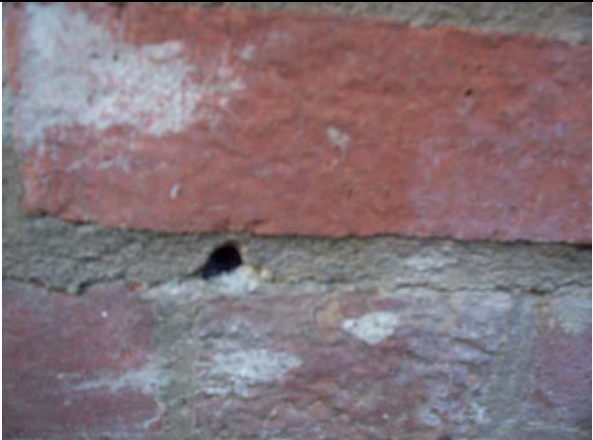
Inspection No:	3	Name of surveyors:	P.Riding		Date:	09.02.2011
Site/address:	Scheme 38, 1-12 Bishopsdale House, Camden, London					
Asbestos detected:	No	Extent	Representative of cavity wall <1m ²	Sample No:	PR003-K0531	
Floor/level:	Ground	Element:		Core sample		
Area/room:	External	Location:		Wall cavity		
Inspection type:	Sampled					
MATERIAL ASSESSMENT						
Product type		1 = Composites, A/C etc.	2 = AIB, boards, ropes, gaskets, paper etc	3 = Lagging, sprayed coatings & loose asbestos		
Extent of damage	0 = Good condition	1 = Slight damage, marks & scratches	2 = Moderate damage	3 = Extensive damage, visible debris		
Surface treatment	0 = Composite materials, plastics, resins, tiles	1 = Enclosed sprays & laggings, sealed AIB, cement etc	2 = Unsealed AIB or sealed lagging & sprays	3 = Unsealed laggings & sprays		
Asbestos type		1 = Chrysotile	2 = Amphibole excluding Crocidolite	3 = Crocidolite

Total Material Assessment Score:						0
Material assessment algorithm totals:		10-12 High risk	7-9 Medium risk	Outline risk category:	Not applicable	
		5-6 Low risk	<4 Very low risk			
Product type 2 or 3 materials will normally require notification to the appropriate body prior to removal under Fully Controlled Conditions.			Removal conditions relevant to this item:	N/A		
However these materials may be removed under Controlled Conditions if less than 1 m2 and/or less than 1 man hour work.						
Pre-Works Hazard Statement						
Is there a significant risk of exposure to respirable asbestos fibres for people entering this area in the period prior to pre-demolition asbestos removal works?						
Surveyor's Opinion:	No	Details:				
Is Immediate Action required?	No	Details:				
Concluding Information						
Comments: Non-asbestos containing core sample from wall and wall cavity.

Recommendations: No further action required.

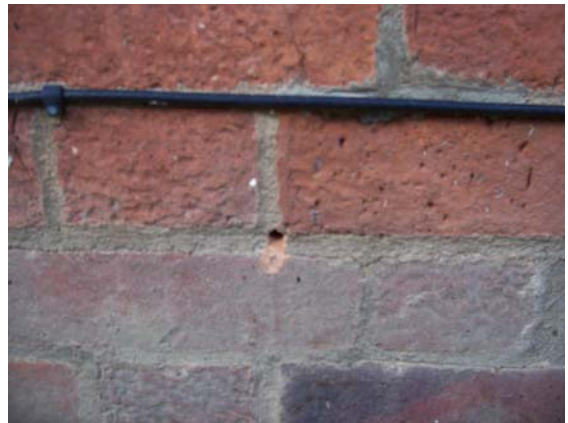
Inspection No:	4	Name of surveyors:	P.Riding		Date:	09.02.2011
Site/address:	Scheme 38, 1-12 Bishopsdale House, Camden, London					
Asbestos detected:	No	Extent	Representative of cavity wall <1m ²	Sample No:	PR004-K0531	
Floor/level:	Ground	Element:	Core sample			
Area/room:	External	Location:	Wall cavity			
Inspection type:	Sampled					
MATERIAL ASSESSMENT						
Product type		1 = Composites, A/C etc.	2 = AIB, boards, ropes, gaskets, paper etc	3 = Lagging, sprayed coatings & loose asbestos		
Extent of damage	0 = Good condition	1 = Slight damage, marks & scratches	2 = Moderate damage	3 = Extensive damage, visible debris		
Surface treatment	0 = Composite materials, plastics, resins, tiles	1 = Enclosed sprays & laggings, sealed AIB, cement etc	2 = Unsealed AIB or sealed lagging & sprays	3 = Unsealed laggings & sprays		
Asbestos type		1 = Chrysotile	2 = Amphibole excluding Crocidolite	3 = Crocidolite

Total Material Assessment Score:						0
Material assessment algorithm totals:		10-12 High risk	7-9 Medium risk	Outline risk category:	Not applicable	
		5-6 Low risk	<4 Very low risk			
Product type 2 or 3 materials will normally require notification to the appropriate body prior to removal under Fully Controlled Conditions. However these materials may be removed under Controlled Conditions if less than 1 m2 and/or less than 1 man hour work.			Removal conditions relevant to this item:	N/A		
Pre-Works Hazard Statement						
Is there a significant risk of exposure to respirable asbestos fibres for people entering this area in the period prior to pre-demolition asbestos removal works?						
Surveyor's Opinion:	No	Details:				
Is Immediate Action required?	No	Details:				
Concluding Information						
Comments: Non-asbestos containing core sample from wall and wall cavity.

Recommendations: No further action required.
