**PRE-REFURBISHMENT
ASBESTOS SURVEY REPORT**
for
Lakehouse
at
Scheme 38, 1-25 Holmesdale House

Job number	K0531	Reviewed by	K.Pearce
Date	14 th February 2011	Signature	 
Issue number	01	Authorised by	Craig Eighteen
Prepared by	J. Clark	Signature	 
Signature

Pre-Refurbishment Asbestos Survey Report
Various Sites in the Camden Borough

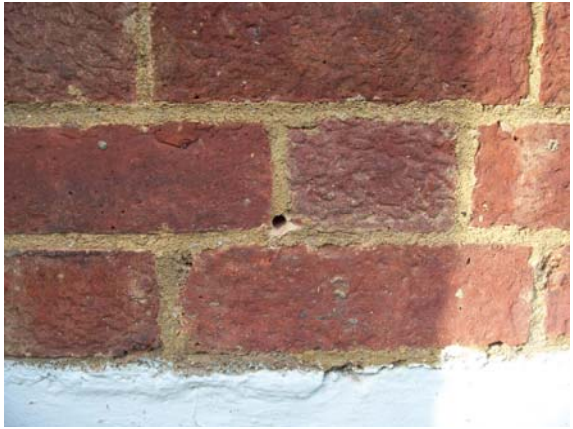
Material assessment algorithm totals:		10-12 High risk	7-9 Medium risk	Outline risk category:	Not applicable	
		5-6 Low risk	<4 Very low risk			
Product type 2 or 3 materials will normally require notification to the appropriate body prior to removal under Fully Controlled Conditions. However these materials may be removed under Controlled Conditions if less than 1 m2 and/or less than 1 man hour work.			Removal conditions relevant to this item:	N/A		
Pre-Works Hazard Statement						
Is there a significant risk of exposure to respirable asbestos fibres for people entering this area in the period prior to pre-demolition asbestos removal works?						
Surveyor's Opinion:	No	Details:				
Is Immediate Action required?	No	Details:				
Concluding Information						
Comments: Non-asbestos containing core sample from wall and wall cavity.

Recommendations: No further action required.

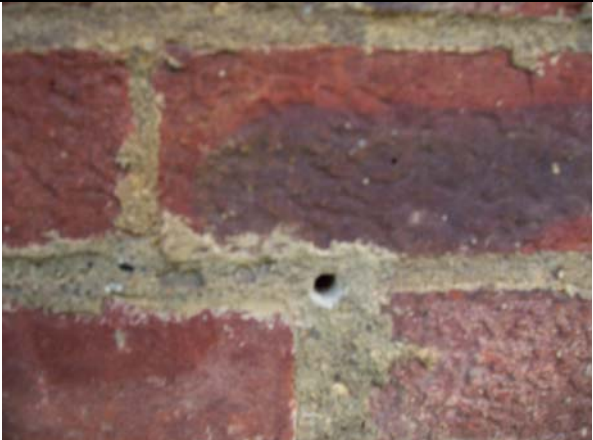
Material assessment algorithm totals:		10-12 High risk	7-9 Medium risk	Outline risk category:	Not applicable	
		5-6 Low risk	<4 Very low risk			
Product type 2 or 3 materials will normally require notification to the appropriate body prior to removal under Fully Controlled Conditions. However these materials may be removed under Controlled Conditions if less than 1 m2 and/or less than 1 man hour work.			Removal conditions relevant to this item:	N/A		
Pre-Works Hazard Statement						
Is there a significant risk of exposure to respirable asbestos fibres for people entering this area in the period prior to pre-demolition asbestos removal works?						
Surveyor's Opinion:	No	Details:				
Is Immediate Action required?	No	Details:				
Concluding Information						
Comments: Non-asbestos containing core sample from wall and wall cavity.

Recommendations: No further action required.

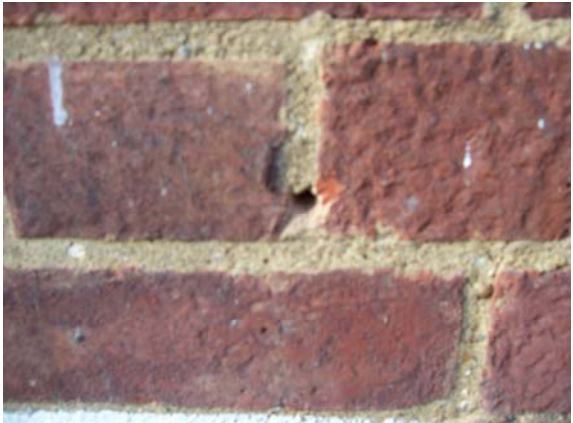
Material assessment algorithm totals:		10-12 High risk	7-9 Medium risk	Outline risk category:	Not applicable	
		5-6 Low risk	<4 Very low risk			
<p>Product type 2 or 3 materials will normally require notification to the appropriate body prior to removal under Fully Controlled Conditions.</p> <p>However these materials may be removed under Controlled Conditions if less than 1 m2 and/or less than 1 man hour work.</p>			Removal conditions relevant to this item:	N/A		
Pre-Works Hazard Statement						
Is there a significant risk of exposure to respirable asbestos fibres for people entering this area in the period prior to pre-demolition asbestos removal works?						
Surveyor's Opinion:	No	Details:				
Is Immediate Action required?	No	Details:				
Concluding Information						
Comments: Non-asbestos containing core sample from wall and wall cavity.

Recommendations: No further action required.
