**PRE-REFURBISHMENT
ASBESTOS SURVEY REPORT**
for
Lakehouse
at
Scheme 38, 1-6 Wharfedale House

Job number	K0531	Reviewed by	K.Pearce
Date	14 th February 2011	Signature	 
Issue number	01	Authorised by	Craig Eighteen
Prepared by	J. Clark	Signature

Pre-Refurbishment Asbestos Survey Report
Various Sites in the Camden Borough

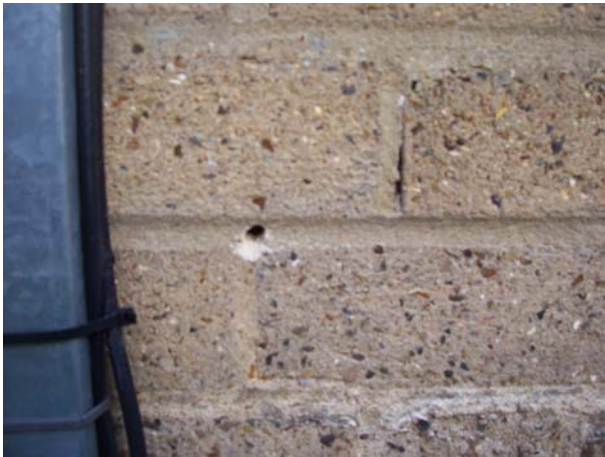
Inspection No:	1	Name of surveyors:	P.Riding		Date:	09.02.2011
Site/address:	Scheme 38, 1-6 Wharfedale House, Camden, London					
Asbestos detected:	No	Extent	Representative of cavity wall <1m ²	Sample No:	PR001-K0531	
Floor/level:	Ground		Element:	Core sample		
Area/room:	External		Location:	Wall cavity		
Inspection type:	Sampled					
MATERIAL ASSESSMENT						
Product type		1 = Composites, A/C etc.	2 = AIB, boards, ropes, gaskets, paper etc	3 = Lagging, sprayed coatings & loose asbestos		
Extent of damage	0 = Good condition	1 = Slight damage, marks & scratches	2 = Moderate damage	3 = Extensive damage, visible debris		
Surface treatment	0 = Composite materials, plastics, resins, tiles	1 = Enclosed sprays & laggings, sealed AIB, cement etc	2 = Unsealed AIB or sealed lagging & sprays	3 = Unsealed laggings & sprays		
Asbestos type		1 = Chrysotile	2 = Amphibole excluding Crocidolite	3 = Crocidolite		
Total Material Assessment Score:						0

Material assessment algorithm totals:		10-12 High risk	7-9 Medium risk	Outline risk category:	Not applicable	
		5-6 Low risk	<4 Very low risk			
Product type 2 or 3 materials will normally require notification to the appropriate body prior to removal under Fully Controlled Conditions. However these materials may be removed under Controlled Conditions if less than 1 m2 and/or less than 1 man hour work.			Removal conditions relevant to this item:	N/A		
Pre-Works Hazard Statement						
Is there a significant risk of exposure to respirable asbestos fibres for people entering this area in the period prior to pre-demolition asbestos removal works?						
Surveyor's Opinion:	No	Details:				
Is Immediate Action required?	No	Details:				
Concluding Information						
Comments: Non-asbestos containing core sample from wall and wall cavity.

Recommendations: No further action required.

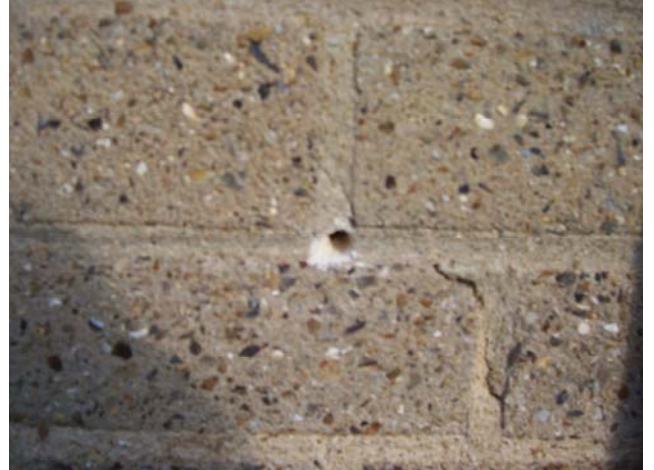
Inspection No:	2	Name of surveyors:	P.Riding		Date:	09.02.2011
Site/address:	Scheme 38, 1-6 Wharfedale House, Camden, London					
Asbestos detected:	No	Extent	Representative of cavity wall <1m ²	Sample No:	PR002-K0531	
Floor/level:	Ground		Element:	Core sample		
Area/room:	External		Location:	Wall cavity		
Inspection type:	Sampled					
MATERIAL ASSESSMENT						
Product type		1 = Composites, A/C etc.	2 = AIB, boards, ropes, gaskets, paper etc	3 = Lagging, sprayed coatings & loose asbestos		
Extent of damage	0 = Good condition	1 = Slight damage, marks & scratches	2 = Moderate damage	3 = Extensive damage, visible debris		
Surface treatment	0 = Composite materials, plastics, resins, tiles	1 = Enclosed sprays & laggings, sealed AIB, cement etc	2 = Unsealed AIB or sealed lagging & sprays	3 = Unsealed laggings & sprays		
Asbestos type		1 = Chrysotile	2 = Amphibole excluding Crocidolite	3 = Crocidolite		
Total Material Assessment Score:						0

Material assessment algorithm totals:		10-12 High risk	7-9 Medium risk	Outline risk category:	Not applicable	
		5-6 Low risk	<4 Very low risk			
<p>Product type 2 or 3 materials will normally require notification to the appropriate body prior to removal under Fully Controlled Conditions.</p> <p>However these materials may be removed under Controlled Conditions if less than 1 m2 and/or less than 1 man hour work.</p>			Removal conditions relevant to this item:	N/A		
Pre-Works Hazard Statement						
Is there a significant risk of exposure to respirable asbestos fibres for people entering this area in the period prior to pre-demolition asbestos removal works?						
Surveyor's Opinion:	No	Details:				
Is Immediate Action required?	No	Details:				
Concluding Information						
<p>Comments: Non-asbestos containing core sample from wall and wall cavity.</p>

<p>Recommendations: No further action required.</p>
